P.I.N. X051.59  
BRIDGE DECK EVALUATION REPORT

<u>Description:</u>	Grand Central Parkway over Winchester Blvd and Cross Island Parkway and Ramp "H" over Cross Island Parkway
<u>BIN:</u>	1065149 and 106514A
<u>GCP Reference Marker:</u>	1120 to 1124
<u>County:</u>	Queens
<u>City of:</u>	New York
<u>Region:</u>	11
<u>Feature Carried:</u>	Grand Central Parkway and GCP Ramp "H"
<u>Feature Crossed:</u>	Cross Island Parkway Winchester Blvd

# IN-DEPTH INSPECTION REPORT

**B.I.N. 1-06514-9 & 1-06514-A**

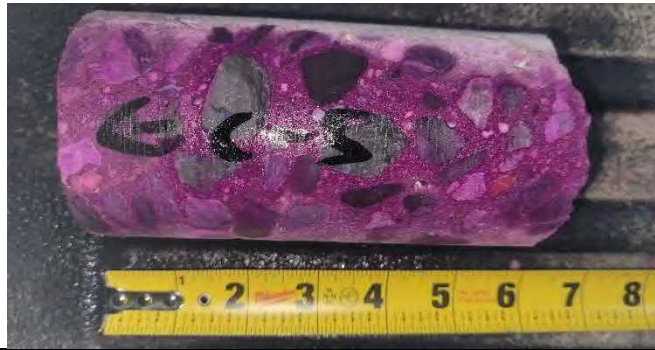
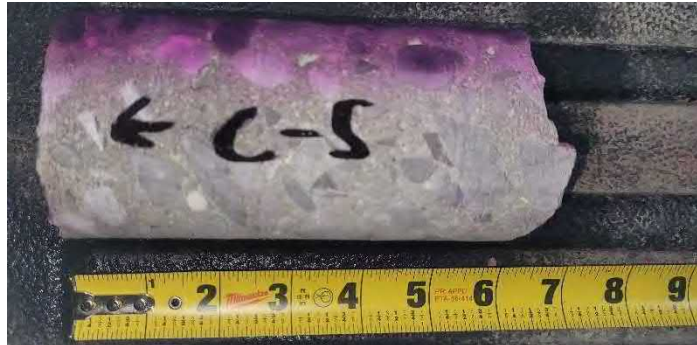
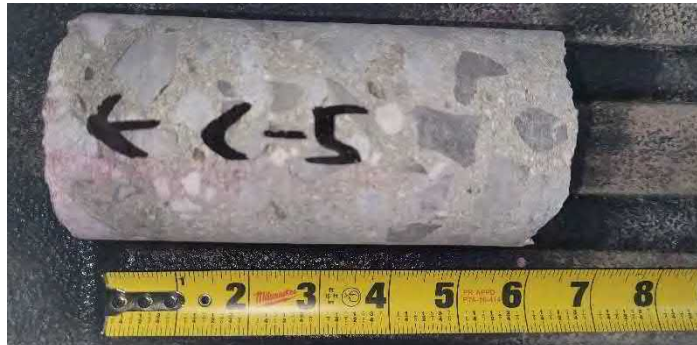
**Core 5**

Length: 5.75"

Location:  
Eastbound - Slow Lane  
Span 7  
21.5' North from South Curb  
28.5' East of Pier 6

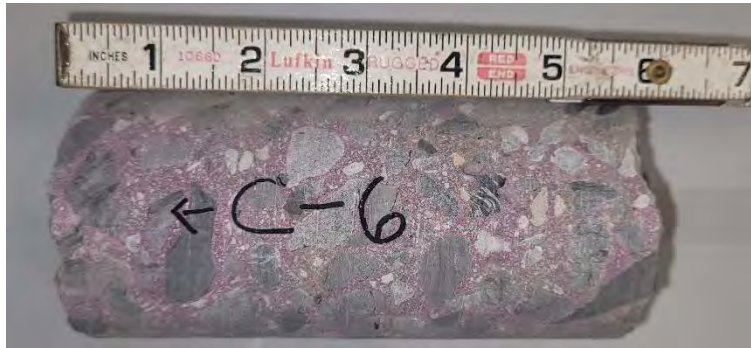
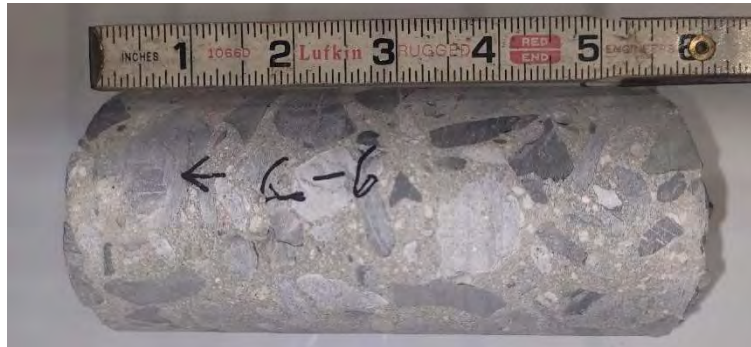
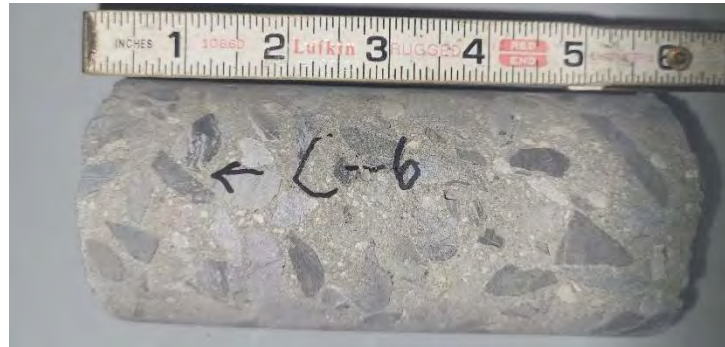
**Core 6**

Length: 6.25"

Location:  
Eastbound – High Speed Lane  
Span 9  
13.5' South of Center Joint  
42' East of Pier 8

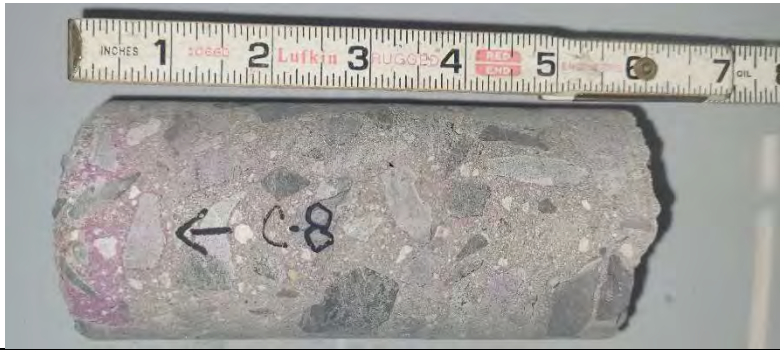
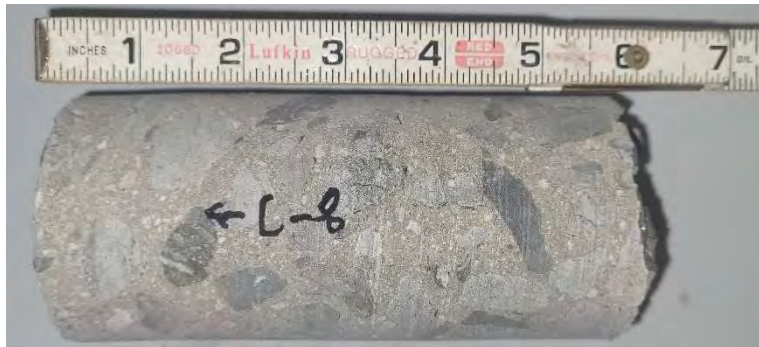
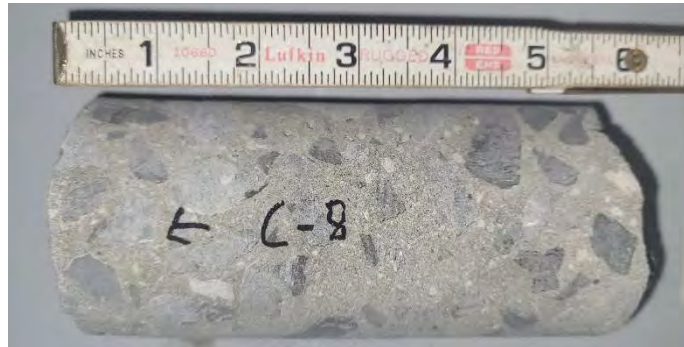
### Core 8

Length: 6"	0" Carbonation	Location: Eastbound – High Speed Lane Span 13 15' South of Center Joint 14.75' East of Pier 12
------------	----------------	--

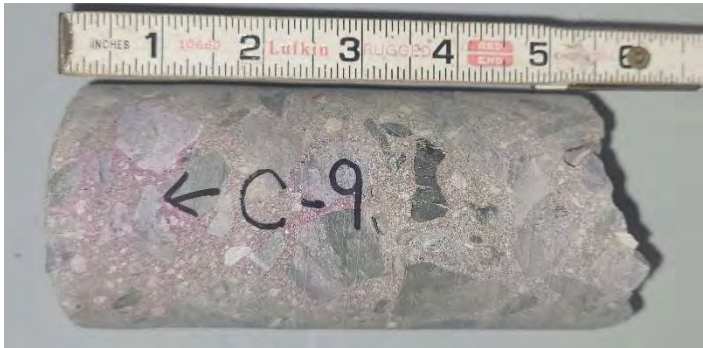
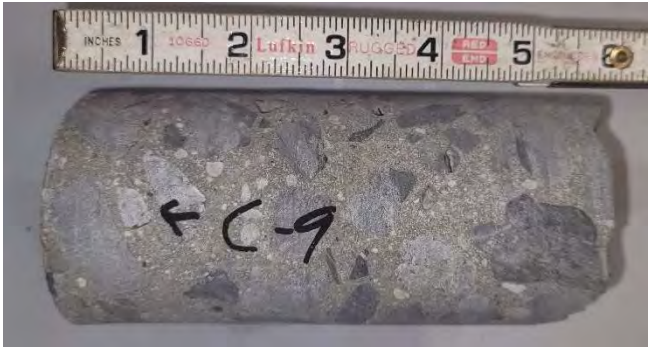
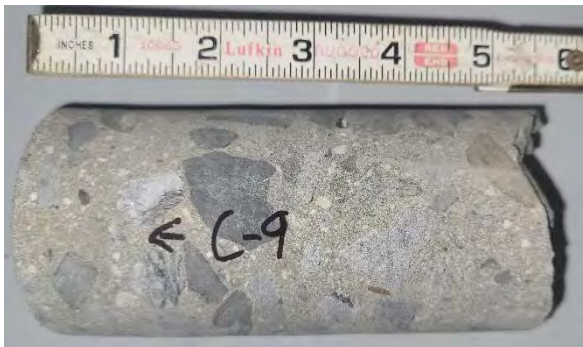
Core 9

Side C		
Length: 6"	0" Carbonation	Location: Eastbound – High Speed Lane Span 15 7.8' South of Center Joint 53.5' East of Pier 41

All five cores are vertical in orientation, and measure ~70 mm (2 ¾ in.) in diameter and 140-150 mm (5 ½ - 5 ⅞ in.) in length. All five cores exhibit a worn or deteriorated top surface that exhibits exposed aggregate particles. Core #5 exhibits exposed coarse aggregate particles and the other four cores show both coarse and fine aggregate particles exposed. The bottom surface of all five cores is a fractured surface in which the fracture passes mostly around coarse aggregate particles; all five cores represent a partial slab thickness. None of the cores contain reinforcement (steel bar, wire mesh, fibers, etc.).

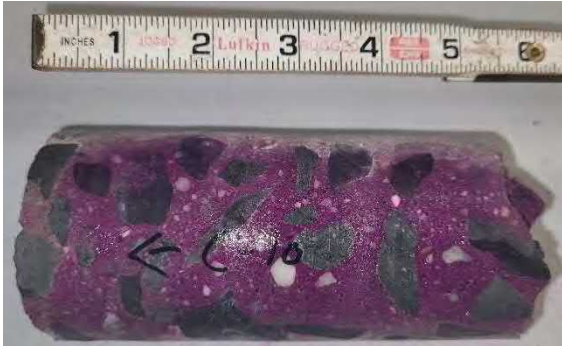
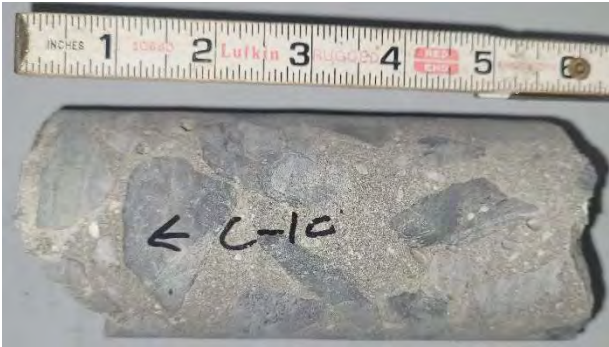
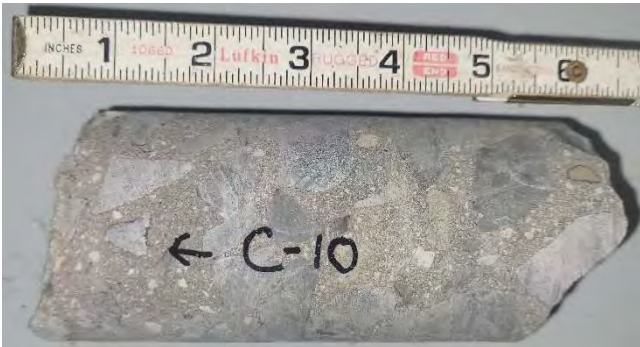
Core 10

Side C		
Length: 6.25"	0" Carbonation	Location: Eastbound – High Speed Lane East Approach 12.5' South of Center Joint 11' East of East Abutment

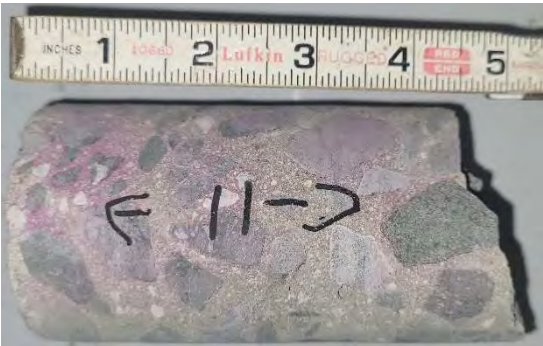
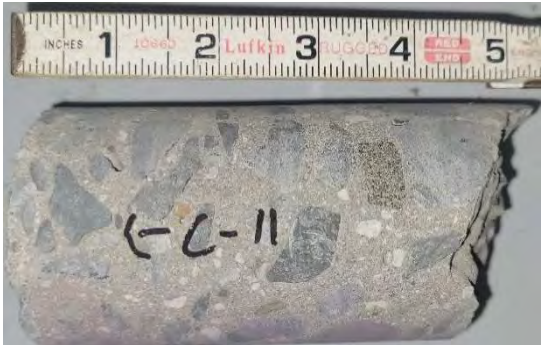
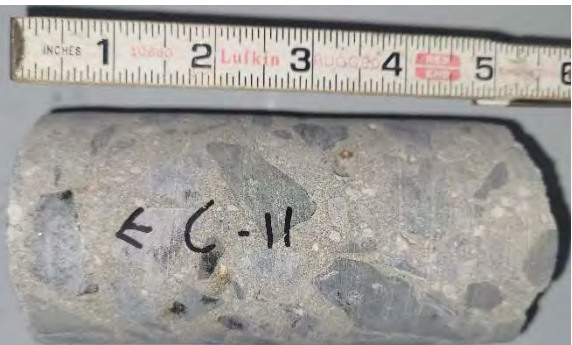
Core 11

Side C		
Length: 5.5"	0" Carbonation	Location: Westbound – Slow Lane Span 12 13.3' South of North Curb 30.6' East of Pier 11

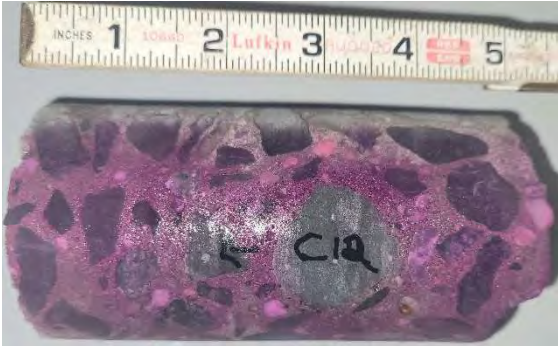
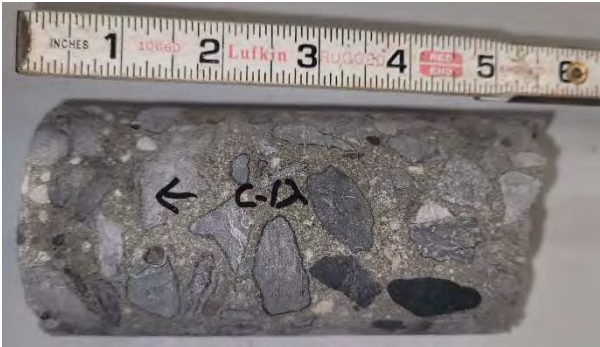
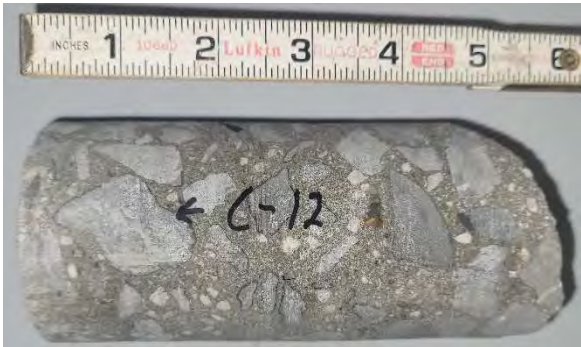
Core 12

Side C		
Length: 6"	0" Carbonation	Location: Westbound – Slow Lane Span 14 7.1' South of North Curb 30.1' East of Pier 13

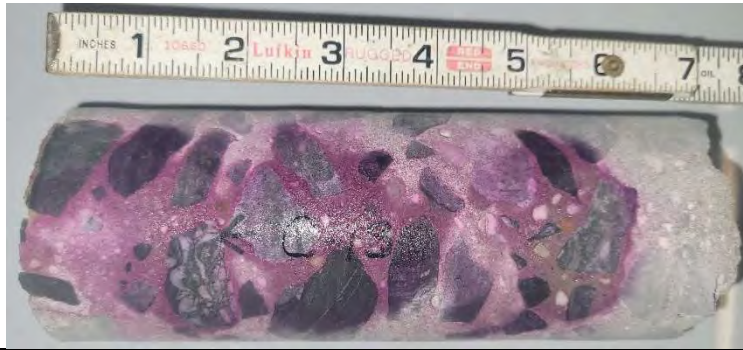
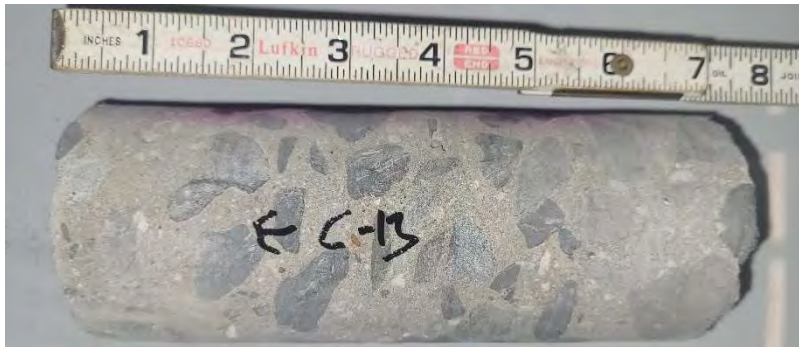
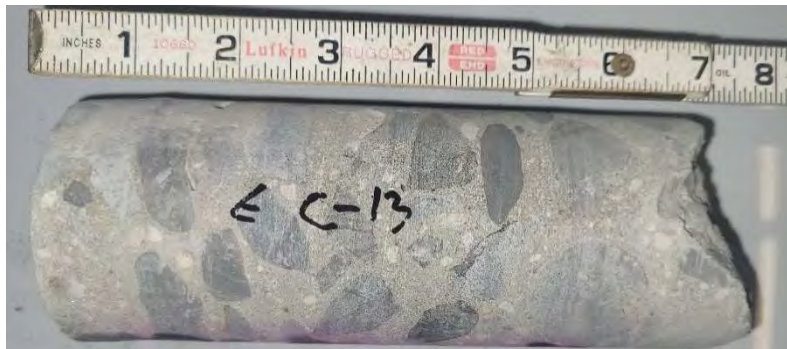
### Core 13

Length: 7.25"

Location:  
Ramp – Left Lane  
H Approach  
10.3' North of South Curb  
7.3' East of East Abutment

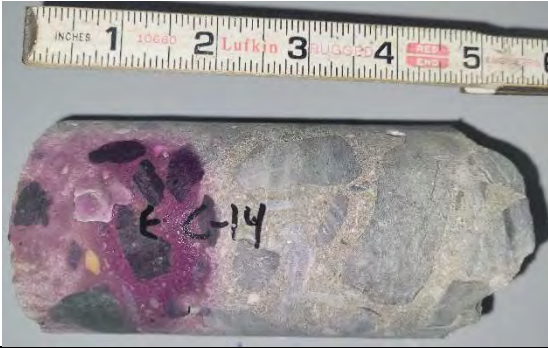
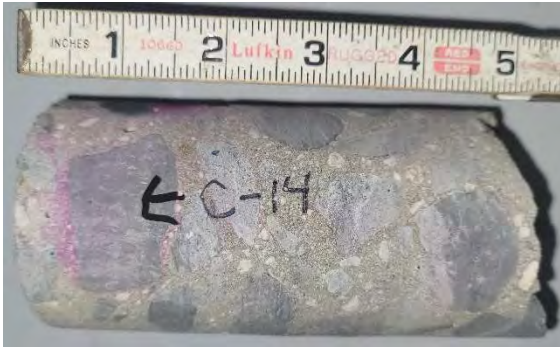
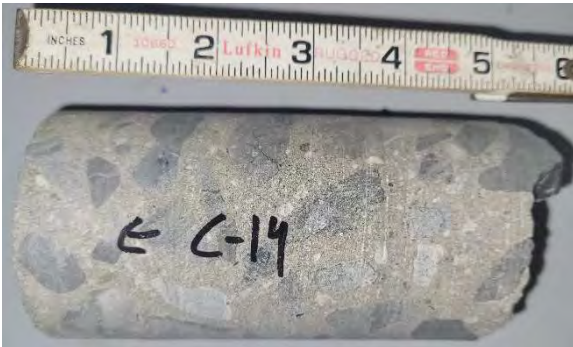
Core 14

Side C		
Length: 5.75"	0" Carbonation	Location: Ramp – Left Lane H Approach 11.6' North of South Curb 28' East of East Abutment

- 2) *Cracks and microcracks.* Core #14 and Core #21 exhibit sub-vertical drying shrinkage cracks and microcracks that cut from the top surface to depths of 9-50 mm ( $\frac{3}{8}$ -2 in.). All five cores contain fairly shallow sub-vertical to diagonal microcracks that cut from the top surface to depths of 1-5 mm (40-200 mil). These microcracks are consistent with wear and/or scaling. Salt scaling deterioration typically manifests as these types of microcracks in concrete exposed to deicer salts.

- 3) *Alkali-silica reaction (ASR).* Core #14 and Core #21 exhibit ASR with no significant damage. In both cores, the severity of ASR is rated *minor* following a rating scheme developed by DRP and assessed to show *Stage IV* ASR using a rating scheme developed by Katayama (2020). No evidence of ASR is observed in Core #5, Core #9 or Core #19.

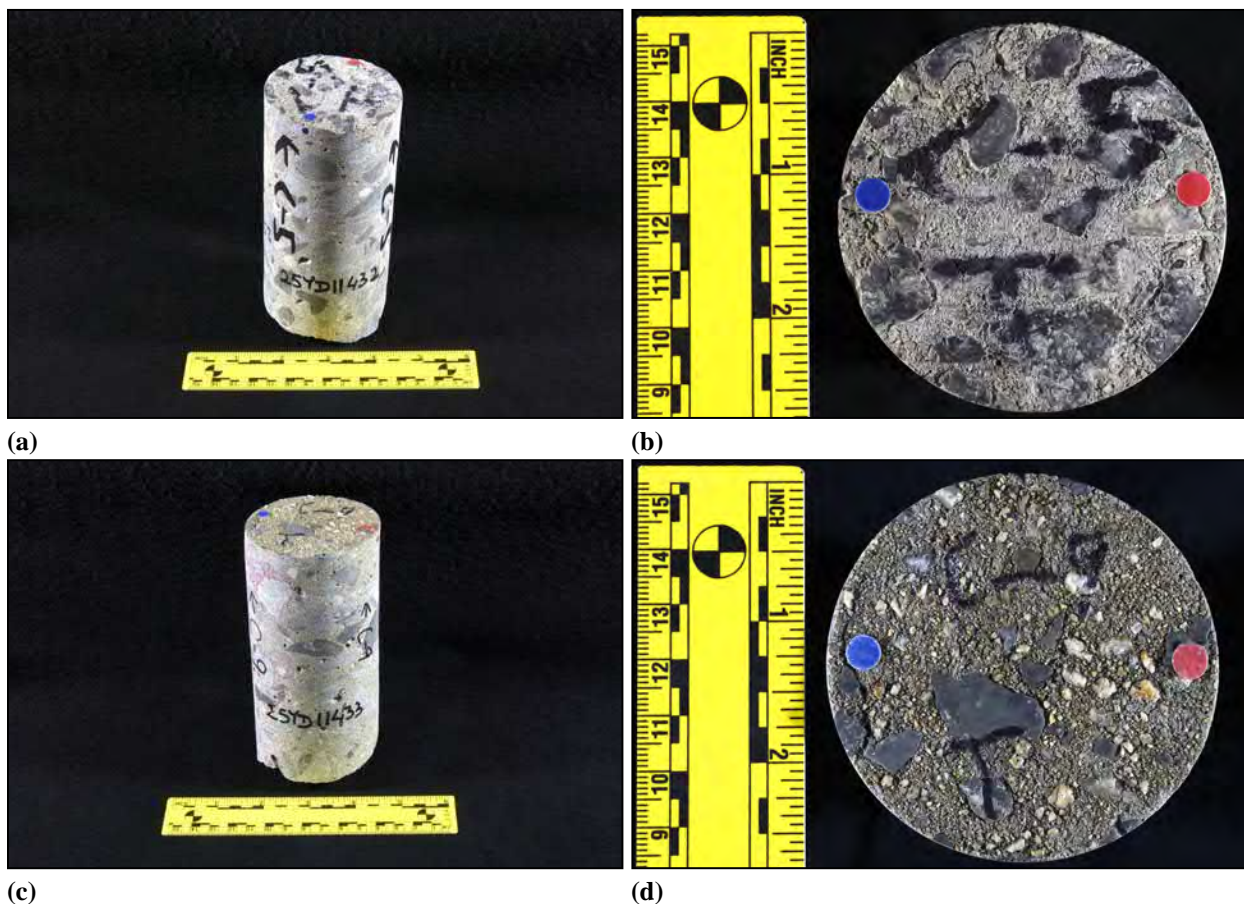
**Figure 1.** Images showing cores in as received condition. Photographs showing (a) oblique view of core top and side of surface and (b) view of top surface of Core #5. Photographs showing (c) oblique view of core top and side of surface and (d) view of top surface of Core #9. Red and blue dots indicate orientation of saw cuts used to prepare the samples. The yellow scale is ~150 mm (6 in.) long; small and large divisions on the yellow scale are in centimeters and inches, respectively.

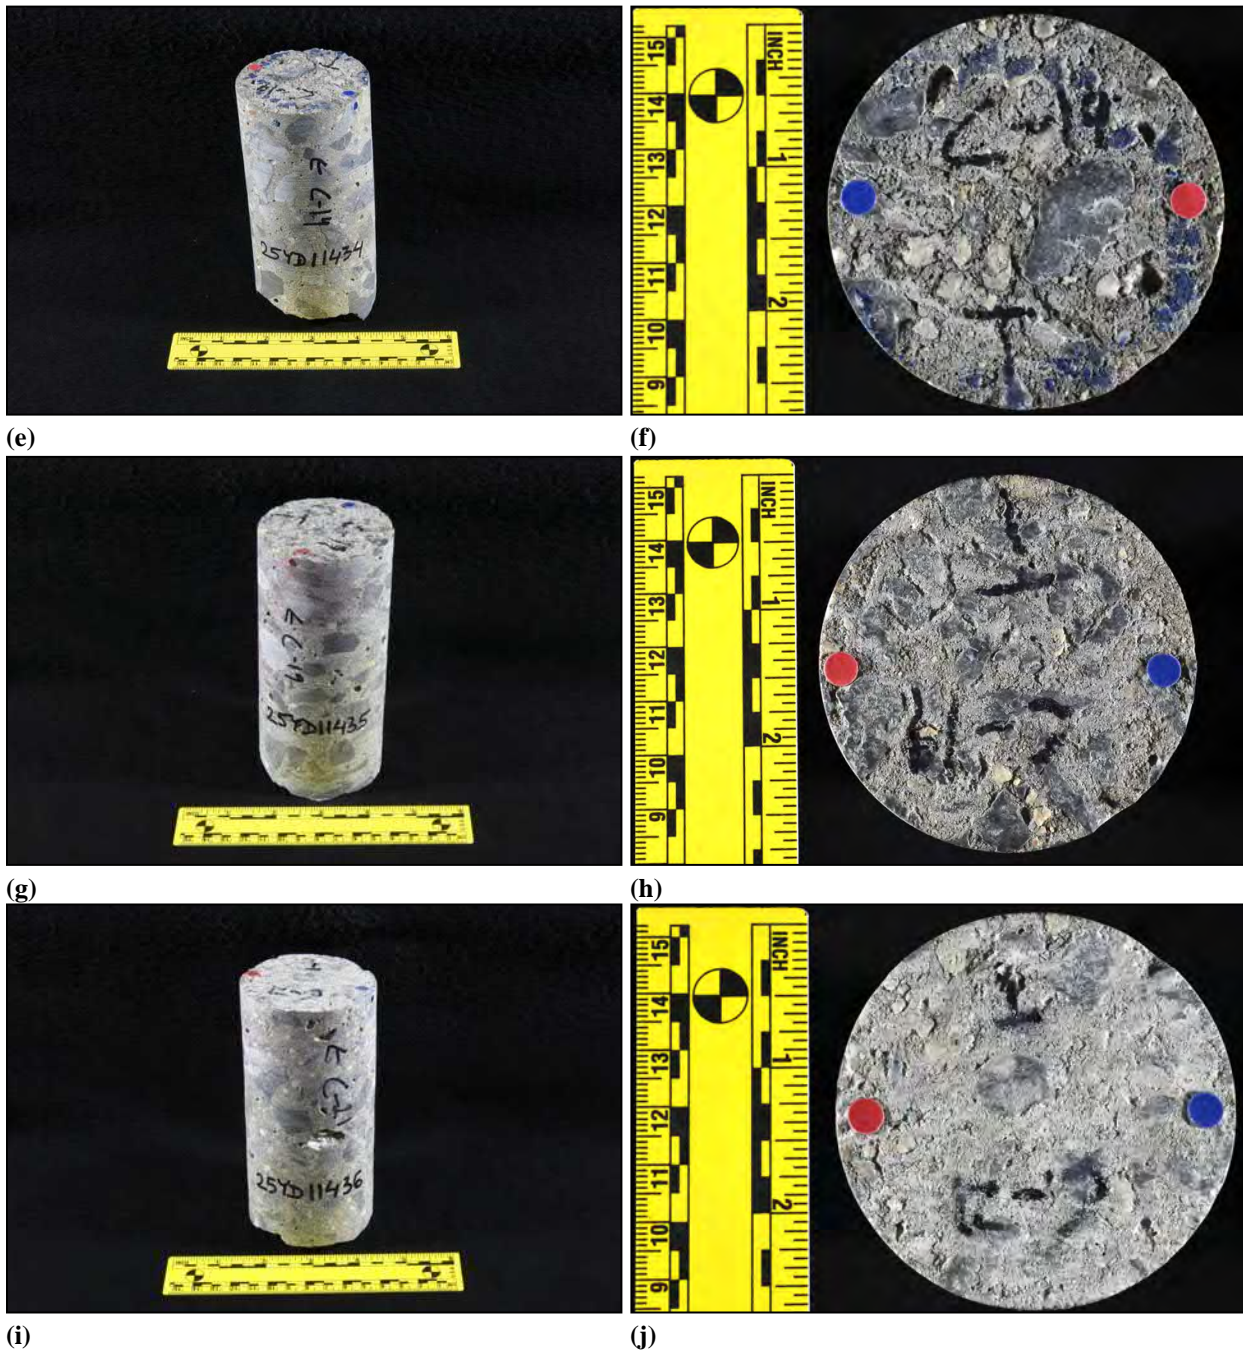
Figure 1 (cont'd). Images showing cores in as received condition. Photographs showing (e) oblique view of core top and side of surface and (f) view of top surface of Core #14. Photographs showing (g) oblique view of core top and side of surface and (h) view of top surface of Core #19. Photographs showing (i) oblique view of core top and side of surface and (j) view of top surface of Core #21. Red and blue dots indicate orientation of saw cuts used to prepare the samples. The yellow scale is ~150 mm (6 in.) long; small and large divisions on the yellow scales are in centimeters and inches, respectively.

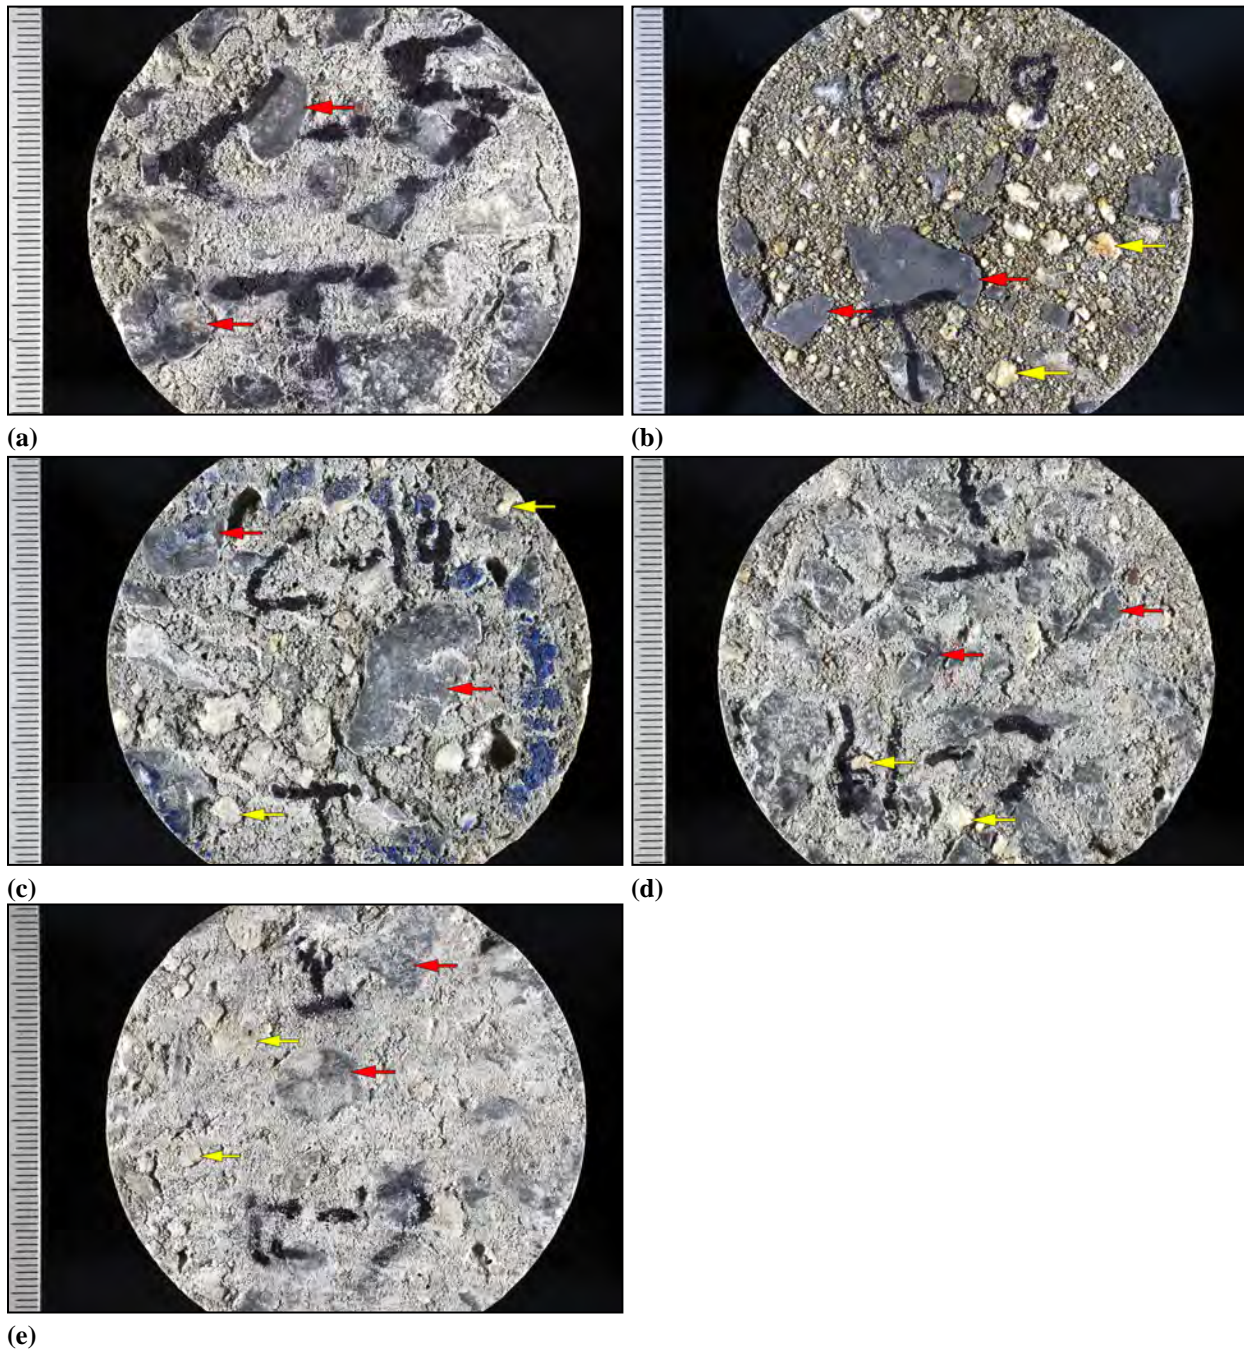
- 1) *Deteriorated top surfaces.* All five cores exhibit a deteriorated top surface that exhibits no original surface and shows coarse aggregate particles exposed in high relief.

**Figure 2. Images showing additional detail of the core top surfaces. Photographs showing exposed coarse aggregate particles (red arrows) and exposed fine aggregate particles (yellow arrows) on the top surface of (a) Core #5, (b) Core #9, (c) Core #14, (d) Core #19 and (e) Core #21. The scale in each image shows millimeter increments.**

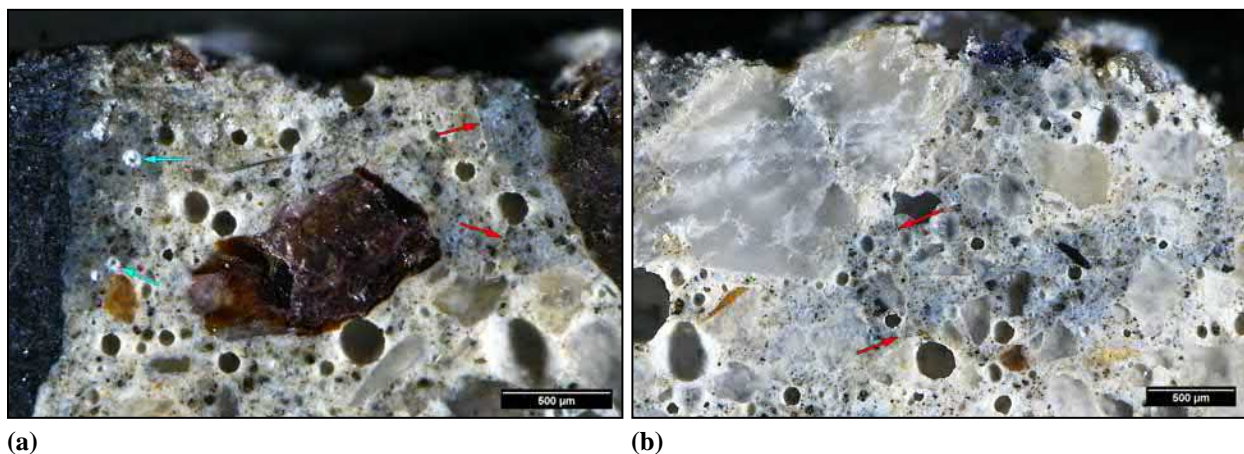
All five cores contain fairly shallow ~25-75  $\mu\text{m}$  (1-3 mil) wide sub-vertical to diagonal microcracks that cut from the top surface into the concrete to depths of 1-5 mm (40-200 mil). These microcracks appear consistent with wear and/or scaling. Salt scaling (due to use of deicer salts) deterioration typically manifests as these types of microcracks in the near-surface region of the concrete.

**Figure 5.** Reflected light photomicrographs showing examples of sub-vertical to diagonal microcracks (red arrows) on the polished surface and in the near-surface region of Core #5. Blue arrows in (a) indicate ettringite in voids.

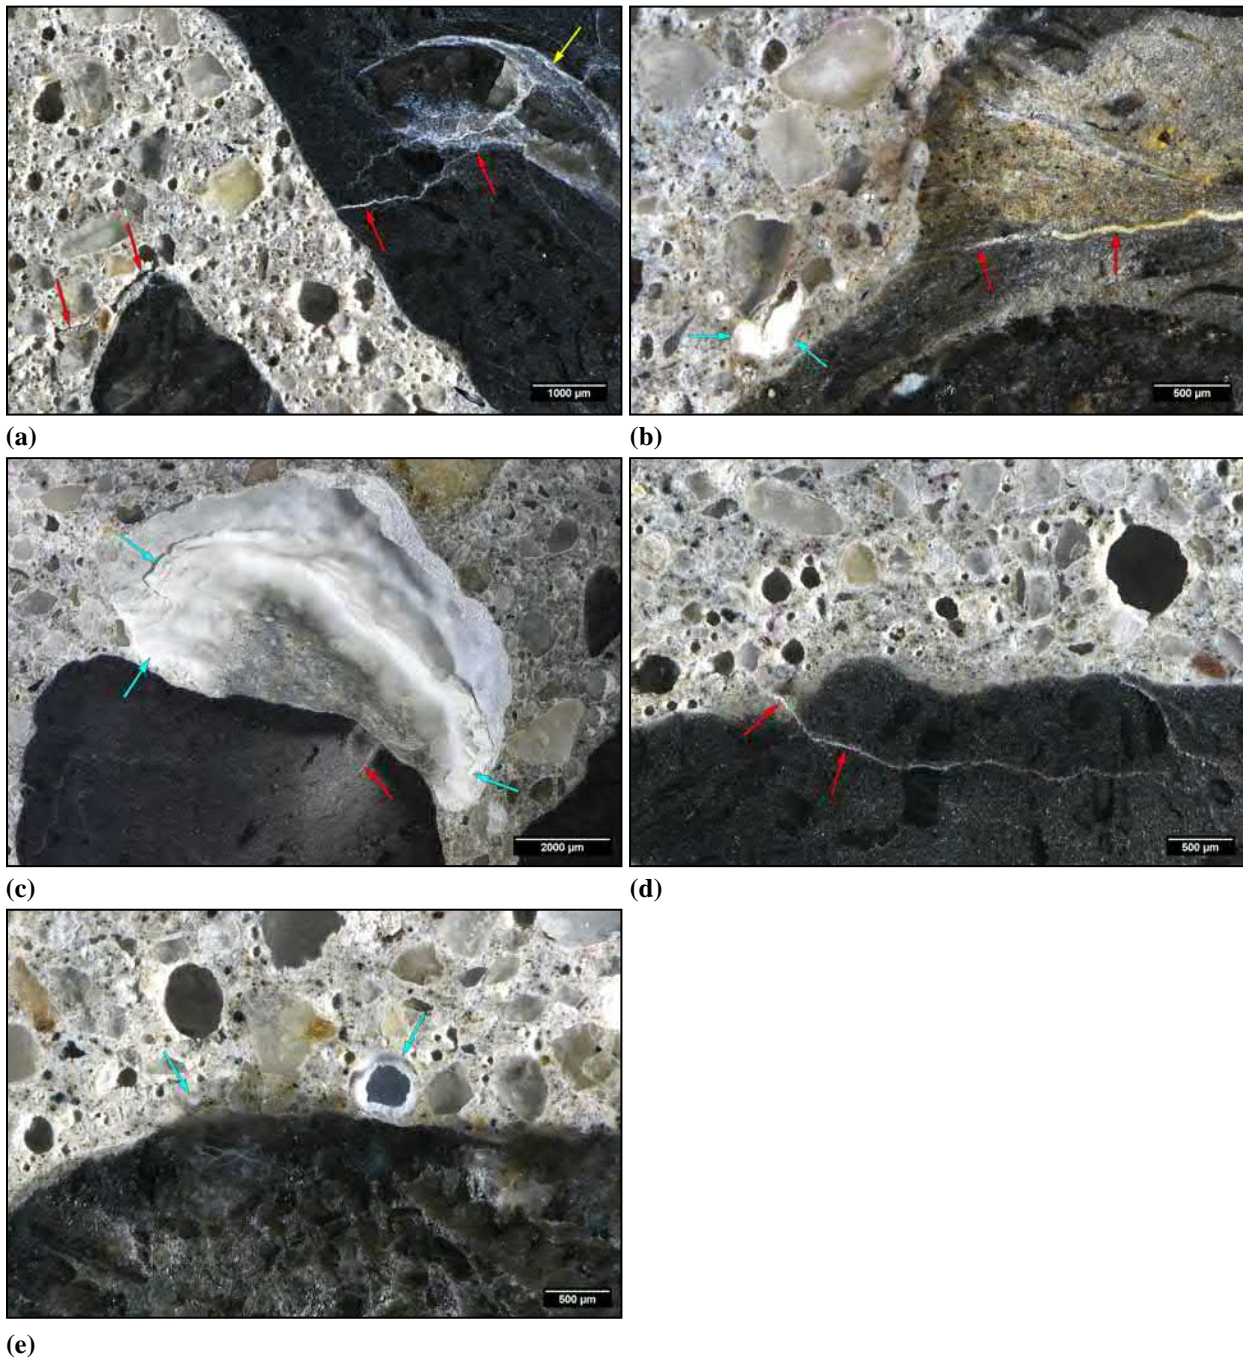
The extent of ASR is limited and, based on the age of the concrete (~40 years), the reaction does not appear to play a significant role in the durability or performance of the concrete pavement.

**Figure 5. Images showing ASR features in Core #14 and Core #21. (a) Reflected light photomicrograph of Core #14 showing ASR microcrack (red arrows) extending outwardly from reactive coarse aggregate particle. Yellow arrow indicates siliceous material within reactive particle. (b) Reflected light photomicrograph of Core #14 showing ASR gel-filled microcrack (red arrows) extending outwardly from reactive coarse aggregate particle and ASR gel partially filling an adjacent void (blue arrows). (c) Reflected light photomicrograph of Core #21 showing ASR gel (blue arrows) lining a void adjacent to a reactive coarse aggregate particle. Red arrow indicates ASR gel-filled microcrack extending from reactive particle into void. (d) Reflected light photomicrograph of Core #21 showing ASR gel-filled microcracks (red arrows) extending outwardly from reactive coarse aggregate particle into the paste. (e) Reflected light photomicrograph of Core #21 showing ASR gel lining to filling a couple voids adjacent to a reactive coarse aggregate particle.**

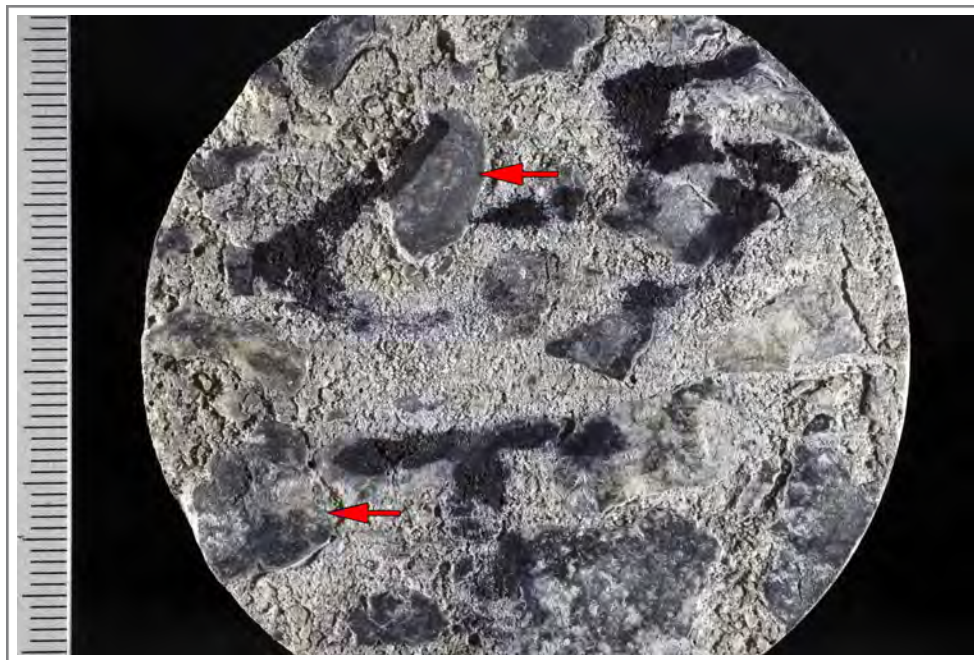
Figure A2. Photograph of the as-received condition of the top surface of the core. Red arrows indicate exposed coarse aggregate particles. Scale shows millimeter increments.

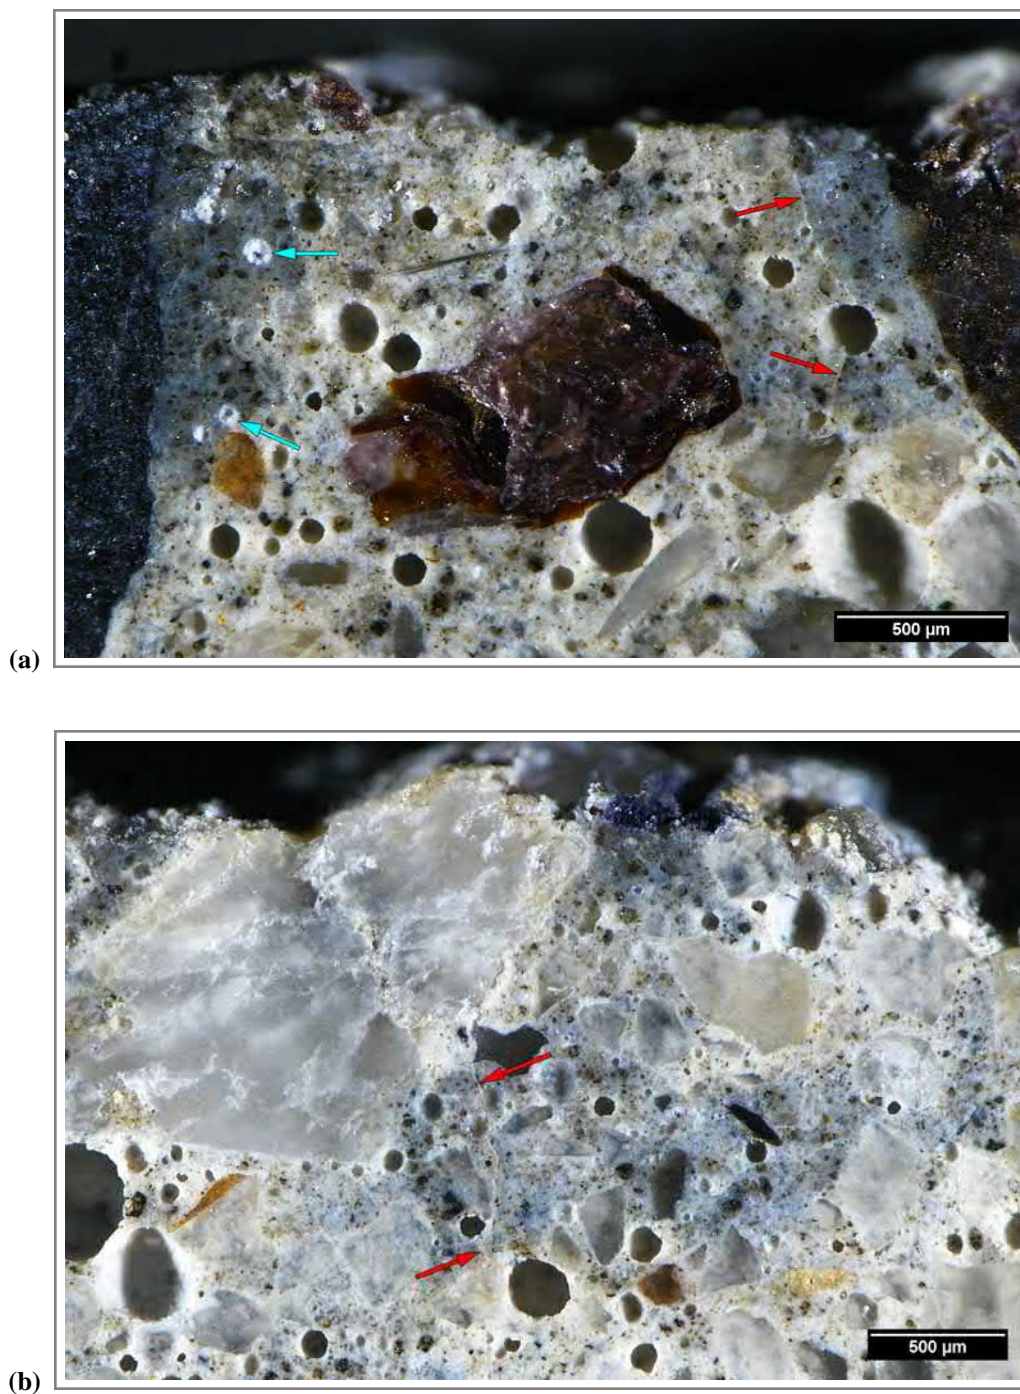
Figure A4. Reflected light photomicrographs showing detail of sub-vertical microcracks (red arrows) in the near-surface region of the paste. Blue arrows in (a) indicate ettringite in voids.

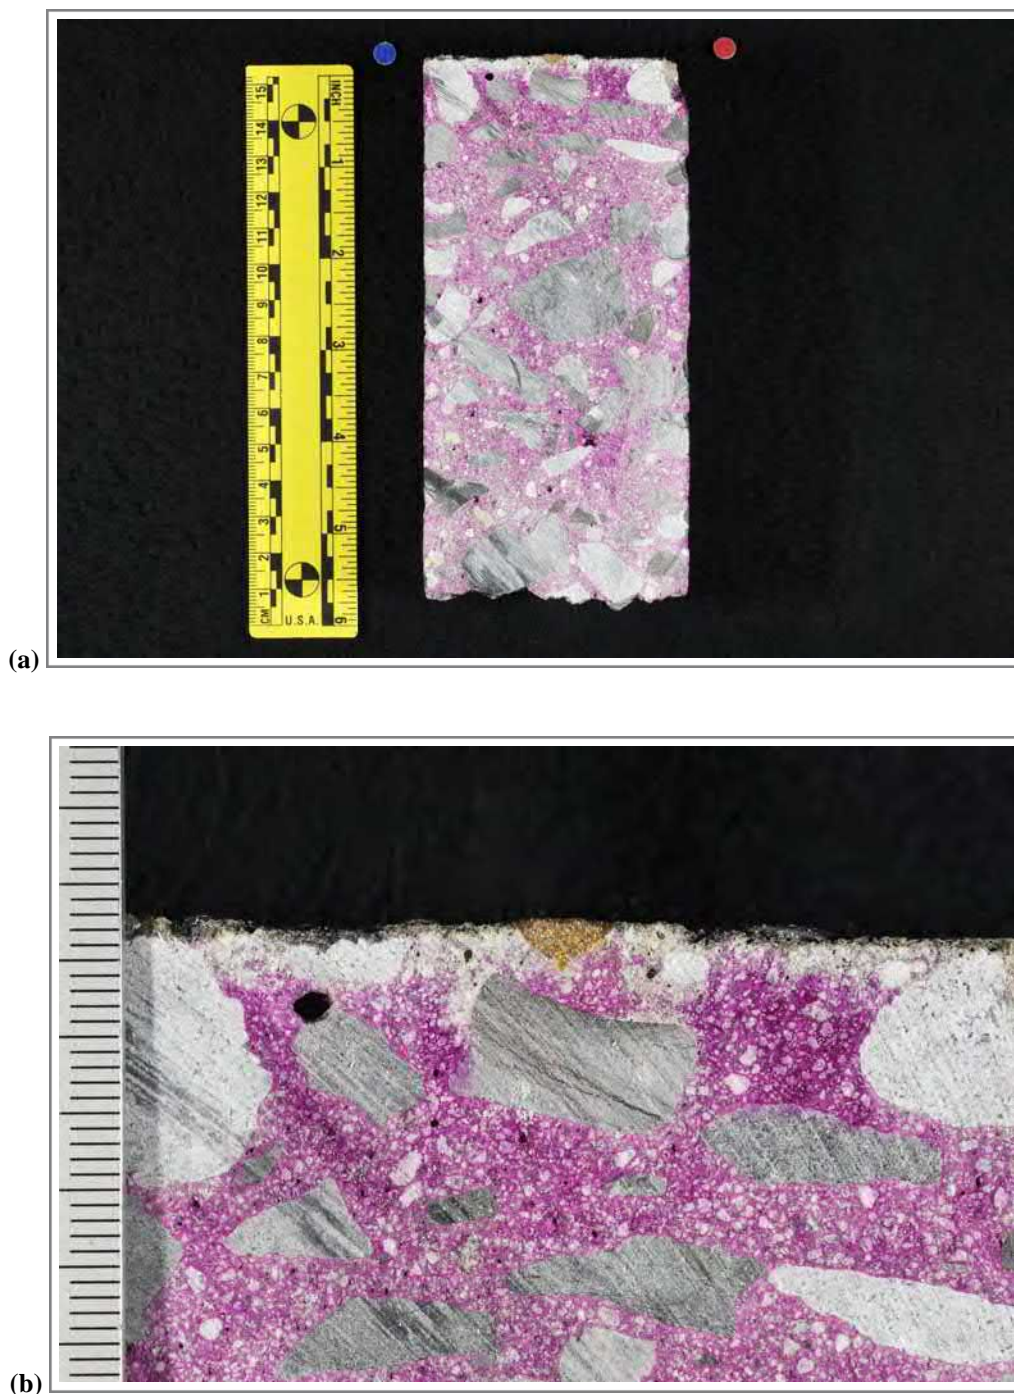
PHENOLPHTHALEIN	The paste is carbonated in the top 1 mm (40 mil) with locally deeper carbonation along sub-vertical microcracks ( <b>Figure A12</b> ). Phenolphthalein staining was applied to a freshly saw-cut cross-sectional surface of the core to determine general depth of paste carbonation.
SECONDARY DEPOSITS	Other than ettringite in voids, no additional secondary deposits are observed.

**Figure A12. Photographs showing (a) overview of phenolphthalein-stained cross-sectional surface of the core, and (b) detail of stained surface at the top of the core. The yellow scale in (a) is ~150 mm (6 in.) long; the small and large divisions are in centimeters and inches, respectively. The scale in (b) shows millimeter increments.**

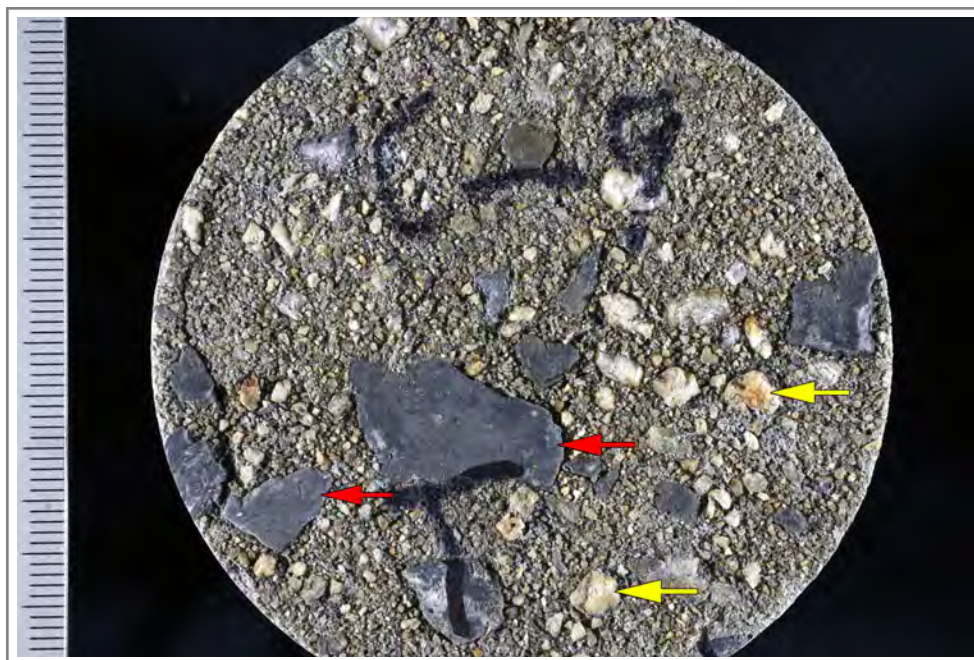
Figure B2. Photograph of the as-received condition of the top surface of the core. Red and yellow arrows indicate exposed coarse and fine aggregate particles, respectively. Scale shows millimeter increments.

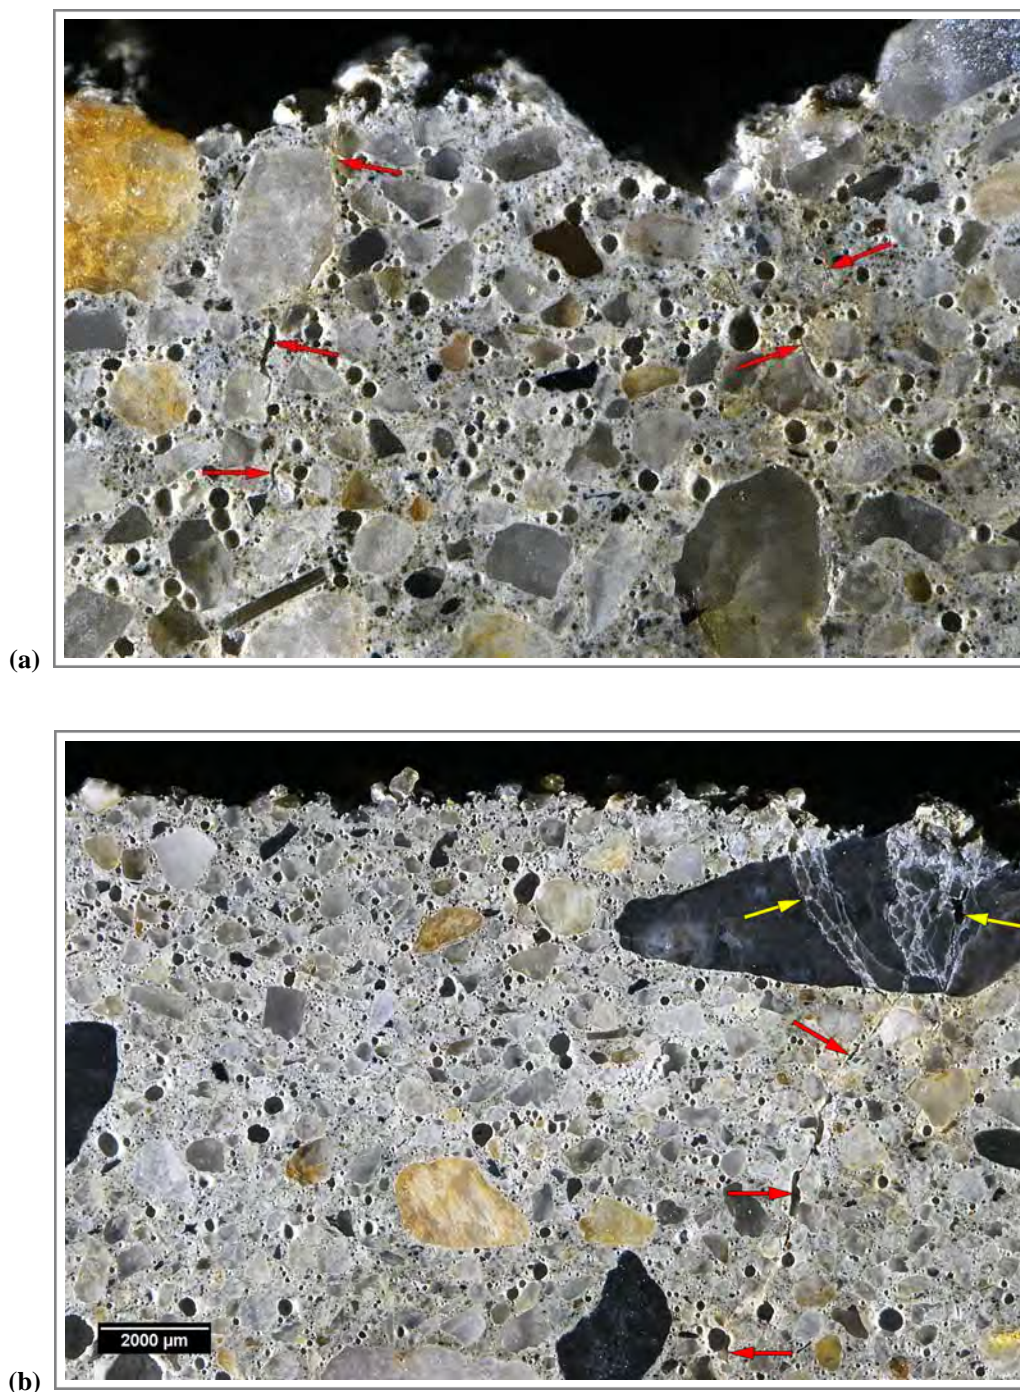
**Figure B4. Reflected light photomicrographs showing detail of sub-vertical microcracks (red arrows) in the near-surface region of the paste. Yellow arrows in (b) indicate microcrack passing through a coarse aggregate particle at the surface.**

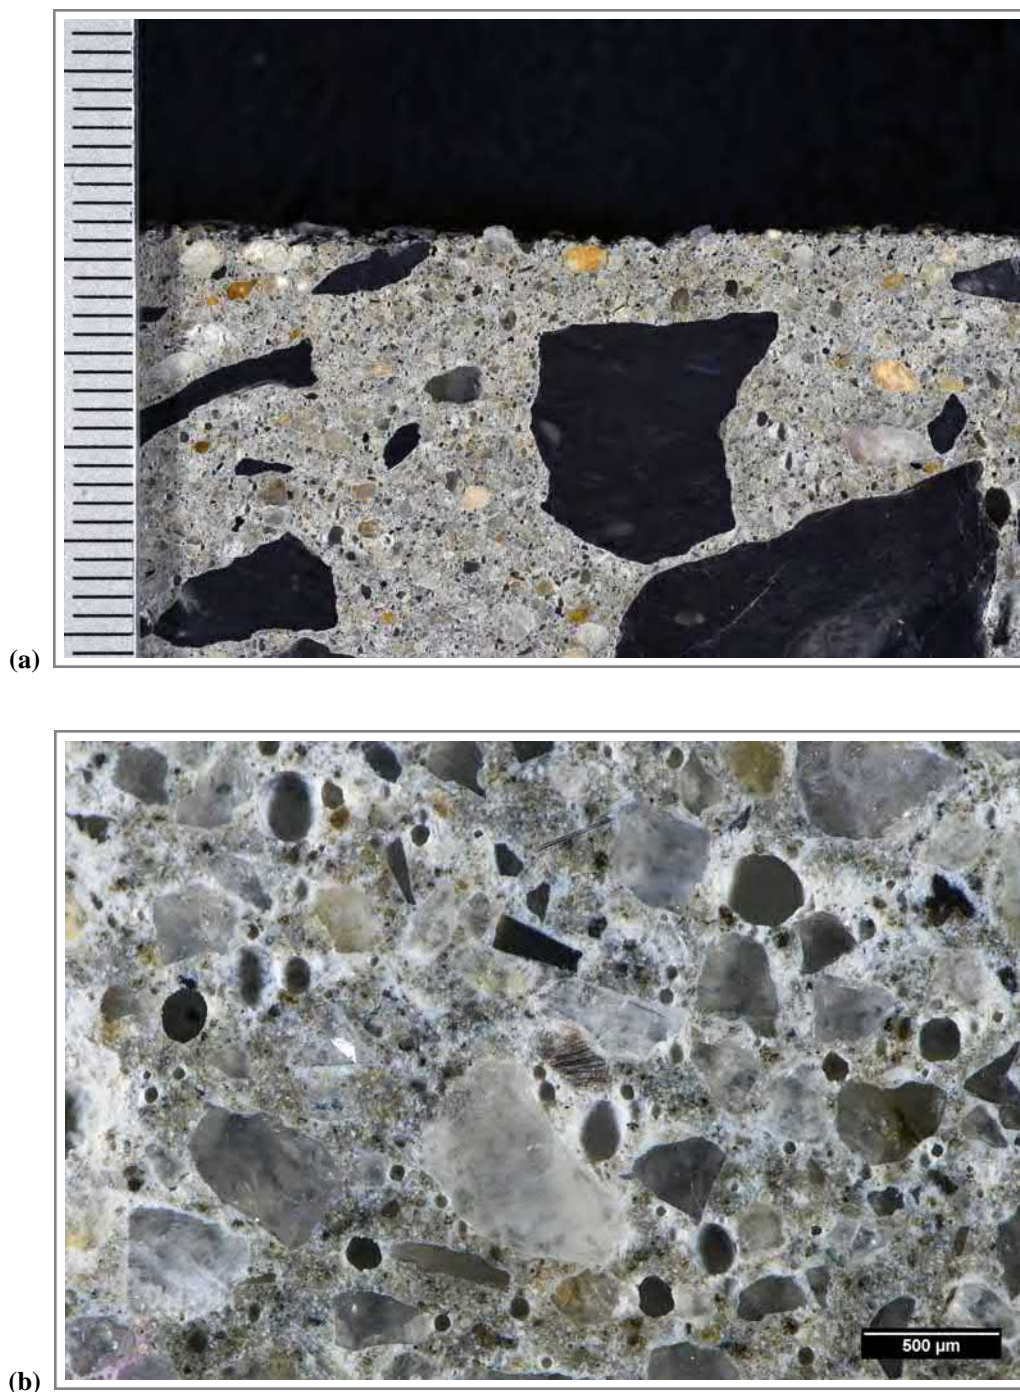
POLISHED SURFACE	Paste in the top 4 mm (¼ in.) is locally light beige; remainder of paste is light gray (Munsell Soil Color GLEY 1 7/N) ( <b>Figure B5</b> ). Paste throughout the core is hard (Mohs 3.5-4). The paste has a smooth texture and sub-vitreous luster.
FRESH FRACTURE	Freshly fractured surfaces show same coloration and luster, and exhibit a moderately weak paste-aggregate bond such that the concrete fractures around ~75% of coarse aggregate particles when struck with a geology hammer in the petrographic laboratory ( <b>Figure B6</b> ).
THIN SECTION	Thin section evaluation was not performed.
ESTIMATED W/C	Thin section evaluation was not performed; w/c was not estimated.

**Figure B5. Images showing detail of the paste. (a) Photograph showing paste in the near-surface region of the core. Scale shows millimeter increments. (b) Reflected light photomicrograph showing paste detail in the body of the core.**
